CAFO FACILITY INSPECTION REPORT

Chino Valley Dairy
FACILITY NAME

03/07/2013
ACTUAL INSPECTION DATE

REPORT PREPARED BY: Anthony D'Angelo (PG Environmental, LLC) ON 03/21/2013

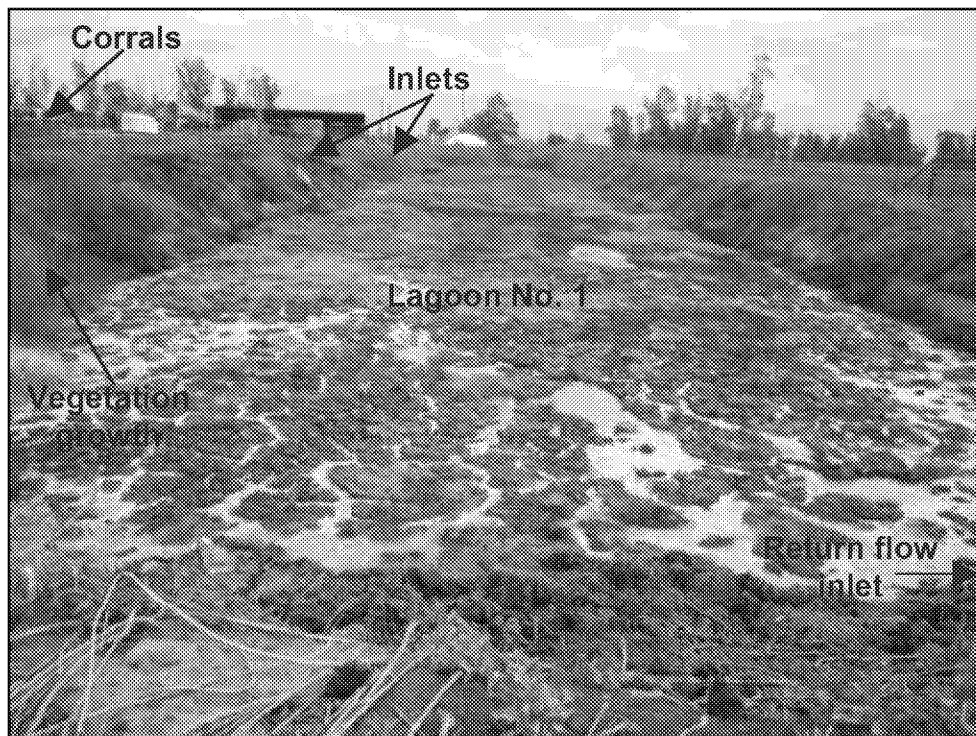
1. Depth markers were not installed in the two (2) wastewater lagoons, located in the central and central-east portions of the Facility as required by Permit Attachment B - Monitoring and Reporting Program, Section I.B.1 (refer to Photos 4 and 11). This is a recurring issue identified in a previous inspection conducted on December 8, 2011.

1. The inspector observed, during the inspection, that depth markers were not installed in lagoon Nos. 1 and 2 located in the central and central-east portion of the Facility, as required by the Permit (refer to Photos 4 and 11). Manure solids was observed inside lagoon No. 1; however, the inspector could not determine the depth of the solids within the lagoon due to the lack of a depth marker (refer to Photos 5 and 6). Lagoon No. 2 contained process wastewater; however, the inspector could not determine the depth of the wastewater within the lagoon due to the lack of a depth marker (refer to Photo 11). This is a recurring issue identified in a previous inspection conducted on December 8, 2011. Permit Attachment B - Monitoring and Reporting Program, Section I.B.1 states that "a marker shall be placed within each pond or impoundment to indicate the minimum capacity necessary to contain the runoff and direct precipitation of the 25-year, 24-hour rainfall event."

2. The inspector observed, during the inspection, accumulated manure solids in lagoon No. 1 in the central portion of the Facility (refer to Photos 4, 5, and 6). Mr. Van Leeuwen stated that the lagoon does not contain an access ramp and it is impossible to access the pond to remove the solids. In addition, he stated that the lagoon had not been cleaned since the Discharger took operational control of the Facility in September 2010. Furthermore, Mr. Van Leeuwen stated that he was currently in the process of designing and constructing an access ramp. Lagoon No. 1 did not contain depth markers; therefore, the inspector was unable to determine the depth of accumulated manure solids in the ponds (refer to Photo 4). Section V - 'Operation and Maintenance', Item E - 'Solids Removal' of the EWMP states "as soon as practicable following the ending of the wet season, solids shall be removed from the containment basins to restore the minimum required available capacity of the basins prior to the next wet season." As a result, the overall capacity of the lagoon at the Facility may be diminished. Provision VII.C.3.a of the Permit states that "the discharger shall design, construct, and maintain containment structures to retain all wastewater within the facility, including all process wastewater and all precipitation on, and drainage through, manured areas resulting from rainfall up to and including a 25-year, 24-hour rainfall event." The Discharger must design and maintain all containment structures per the approved EWMP as required by Provision VII.C.3.a of the Permit.

3. The inspector observed, during the inspection, that vegetation growth potentially affecting the containment structure capacity was present in lagoon No. 1 (refer to Photos 4 and 7). Mr. Van Leeuwen stated that the lagoon does not contain an access ramp and had not been maintained since the Discharger took operation control of the Facility in September 2010. Section V - 'Operation and Maintenance' of the EWMP states "weed abatement measures...should be used to control weeds in fields, lagoons, wastewater transport channels, and wastewater access paths." Weed abatement practices were not conducted to control vegetation growth in lagoon No. 1 at the Facility. As a result, the overall capacity of the lagoon at the Facility may be diminished. Provision VII.C.3.a of the Permit states that "the discharger shall design, construct, and maintain containment structures to retain all wastewater within the facility, including all process wastewater and all precipitation on, and drainage through, manured areas resulting from rainfall up to and including a 25-year, 24-hour rainfall event." The Discharger must design and maintain all containment structures per the approved EWMP as required by Provision VII.C.3.a of the Permit.

Photograph 4. View facing east of lagoon No. 1. Note the lack of a depth marker. Also note Mr. Marty Van Leeuwen (Manager, Chino Valley Dairy) stated that the lagoon had not been cleaned since the Discharger began operating the dairy in September 2010.

1. Verify depth markers have been installed in lagoon Nos. 1 and 2
2. Verify daily inspections are conducted during the wet season
3. Verify that the EWMP is fully implemented onsite
4. Verify lagoon No. 1 has been maintained per the EWMP
5. Verify all manure from corral areas is contained onsite

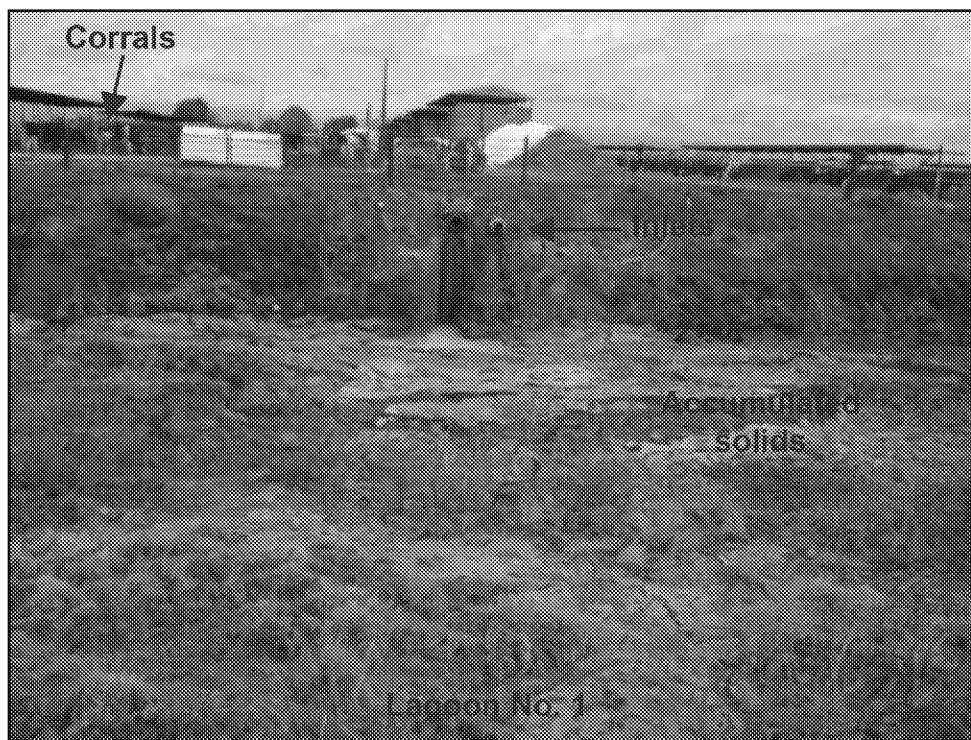
2. The EWMP was not fully implemented onsite at the Facility as required by the Permit. Section V - 'Operation and Maintenance' of the EWMP states that "lagoon solids shall be removed every summer to ensure full capacity in the lagoons before the start of the next winter season." Specifically, accumulated manure solids was observed in lagoon No. 1 (refer to Photos 4, 5, and 6). Mr. Van Leeuwen stated that the lagoon does not contain an access ramp and it is impossible to access the pond to remove solids. In addition, he stated that the lagoon had not been cleaned since the Discharger took operational control of the Facility in September 2010. Furthermore, Mr. Van Leeuwen stated that he was currently in the process to design and construct an access ramp on the south embankment of the lagoon. Lagoon No. 1 did not contain depth markers; therefore, the inspector was unable to determine the depth of accumulated manure solids in the lagoon (refer to Photo 4). As a result, the Discharger was not fully implementing the approved EWMP or ensuring adequate containment capacity within the lagoons. Provision VII.C.3.b of the Permit states that "the discharger shall develop and fully implement an Engineered Waste Management Plan (EWMP) acceptable to the Executive Officer." The Discharger shall fully implement the EWMP as required by Provision VII.C.3.b of the Permit.

Photograph 5. View facing north of the corral and feed lane floor drain outlets into the north side of lagoon No. 1. Note the accumulated solids in the lagoon.

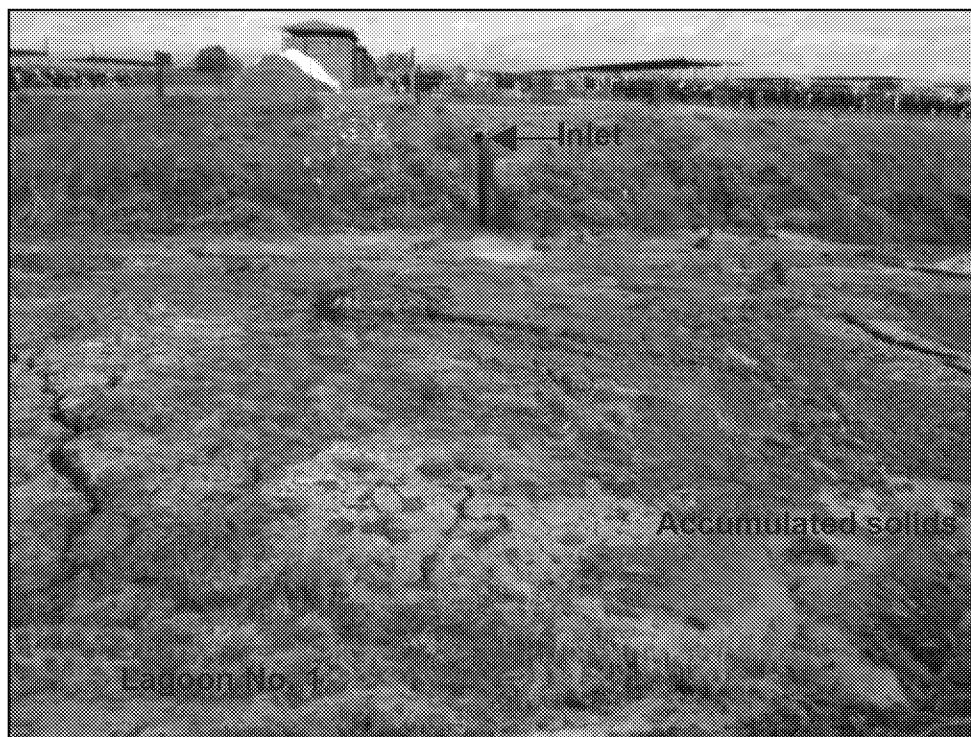
Photograph 6. View facing north of a process wastewater outlet into the north side of lagoon No. 1. Note the accumulated solids in the lagoon.

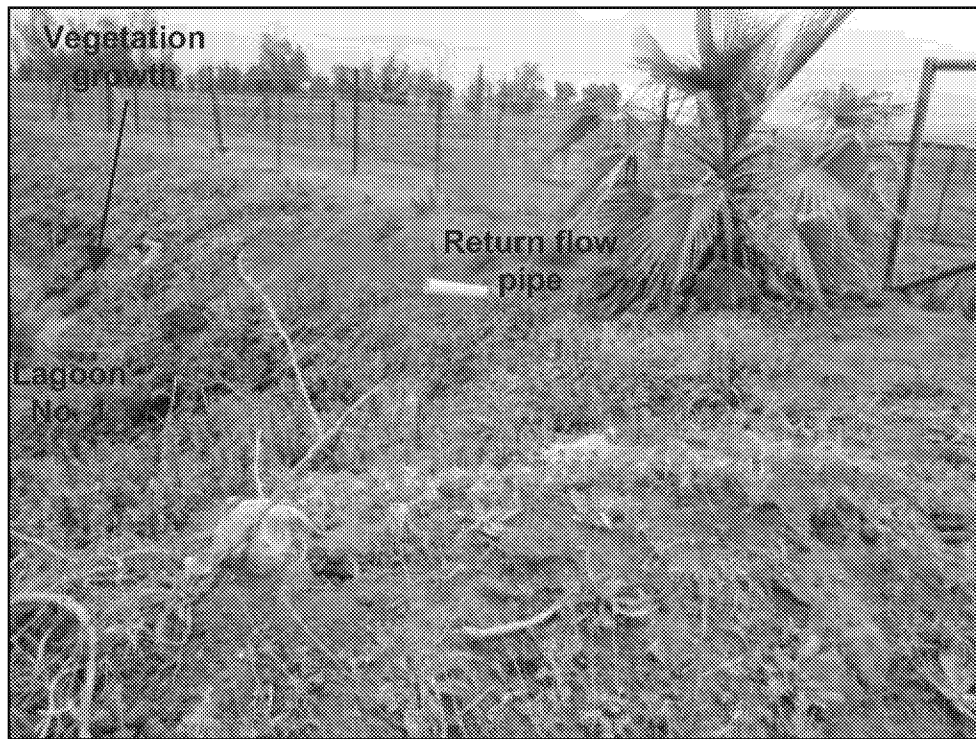
Photograph 7. View facing southeast of the return flow outlet pipe into the southwest corner of lagoon No. 1. Note return flow (i.e., storm water runoff and/or process wastewater from land application) is collected and pumped from the southwest corner of the Facility. Note the vegetation growth in the lagoon.

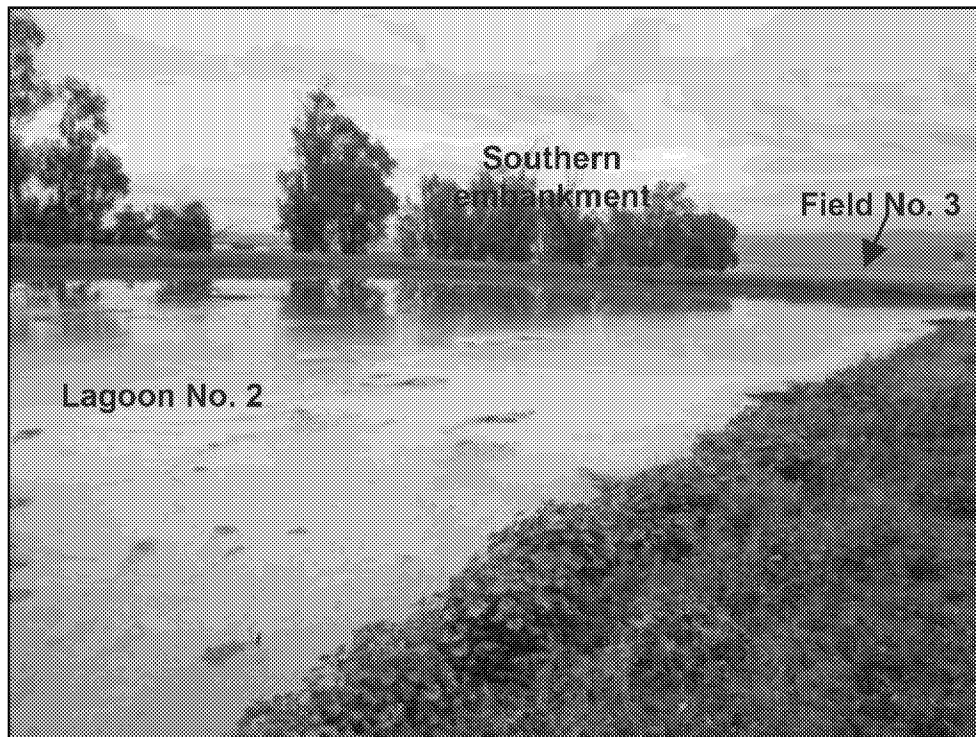
Photograph 11. View facing southeast of lagoon No. 2. Process wastewater from the lagoon is released through the southern embankment via two valves for irrigation of field No. 3. Note the lagoon did not contain a depth marker.

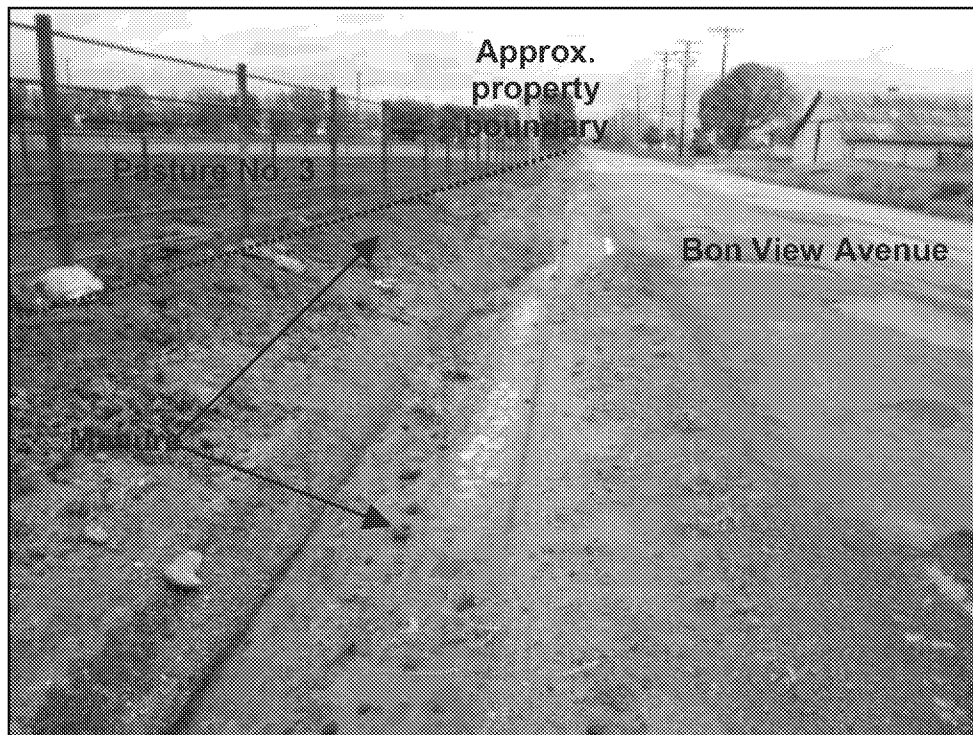
3. A release of manure offsite was observed along the eastern Facility perimeter onto Bon View Avenue from the northeastern pastures (refer to Photos 18 and 19). A release of manure offsite to land and property not owned or controlled by the Discharger is prohibited by Discharge Prohibitions IV.A-B of the Permit.

1. The inspector observed, during the inspection, a release of manure offsite from the northeastern pastures onto Bon View Avenue along the eastern Facility perimeter (refer to Photos 18 and 19). This potential violation was observed by the inspector after departing the Facility; therefore, it was not discussed with the Facility

representative during the inspection closing conference. A release of manure offsite to land and property not owned or controlled by the Discharger is prohibited by Discharge Prohibitions IV.A-B of the Permit.

Photograph 18. View facing north along Bon View Avenue of evidence of a previous manure release offsite onto Bon View Avenue from pasture Nos. 3 and 4 in the northeastern portion of the Facility.

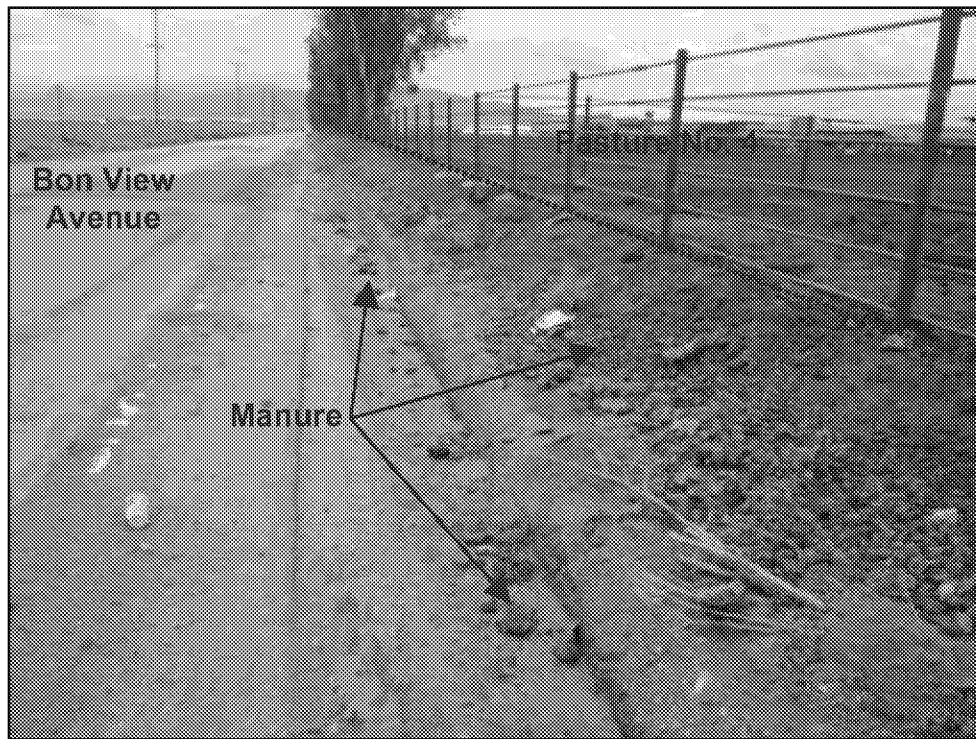
Photograph 19. View facing south along Bon View Avenue of a previous release of manure offsite onto Bon View Avenue from pasture Nos. 3 and 4 in the northeastern portion of the Facility.
